A Reversible Beverage at ZL3IX

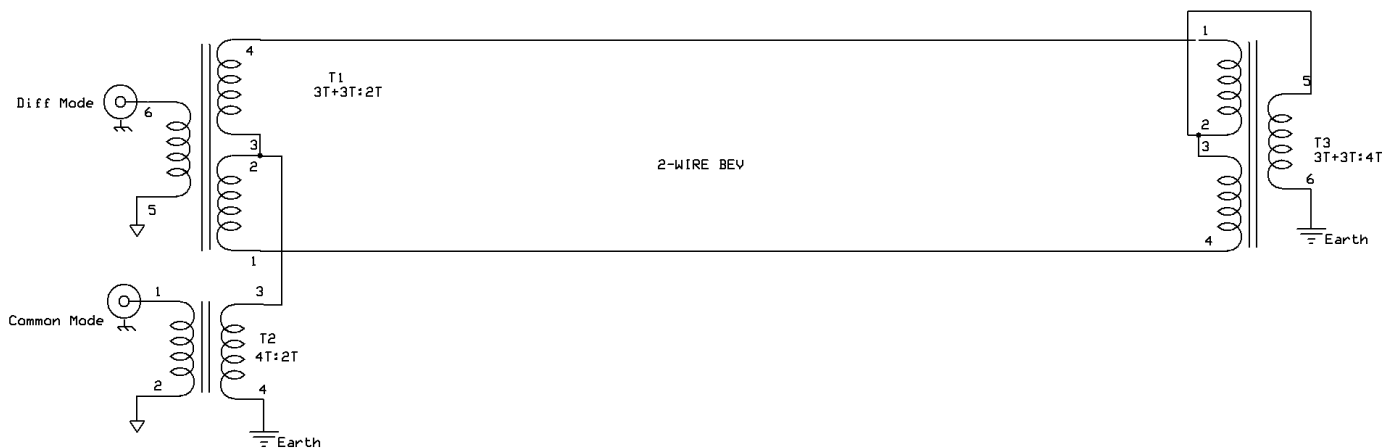
A reversible Beverage uses the orthogonality between common mode and differential mode currents on a 2-wire line to provide independent reception of signals originating from both ends. (In this context, I use the word “orthogonality” meaning “independence of each other”, rather than in phase quadrature). In the diagram below, consider what happens for a wave arriving from the right (call this the forward direction). It will induce equal in-phase currents on the two wires, which will be summed on the secondary of T1, and appear at its centre tap. The combined current produces a signal at the primary of T2. This is the common mode signal.

In contrast, a wave arriving from the left (the reverse direction) will also induce equal in-phase currents on the two wires, which will be summed at the secondary of reflection transformer T3, and appear at its centre tap. The centre tap is connected to the primary of T3, the other side of which is grounded. By transformer action, the current in the primary produces a differential mode current in the secondary, which then travels back along the line to T1. Since the currents so produced are in anti-phase, they will produce a signal at the primary of T1. This is the differential mode signal.

Thus signals arriving from left and right are available individually at the common mode and differential mode connectors respectively.

General Schematic of 2-Wire Beverage

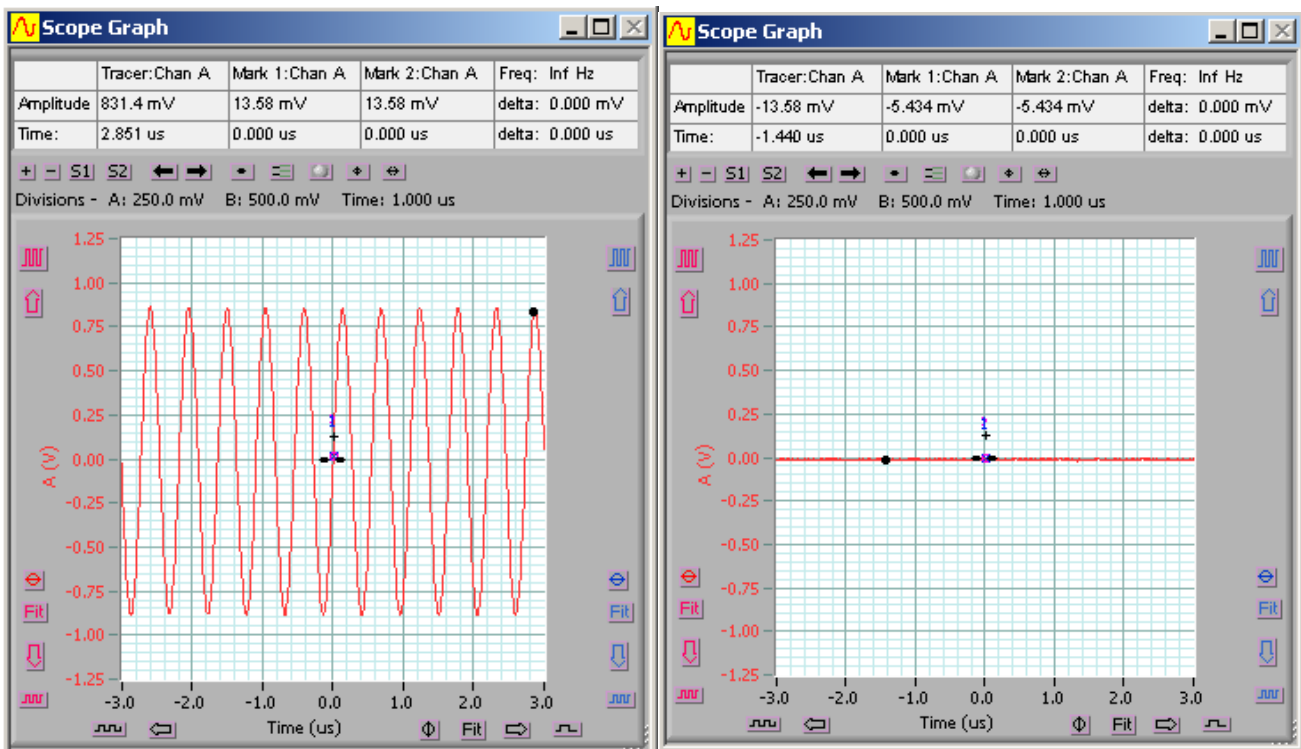
Feed CT of T1, CM Output

Feed CT of T1, DM Output

In the both the scope traces above, the centre tap of T1 is fed with signal. The left hand trace shows the signal appearing at the common mode output, while the right hand trace shows the signal appearing at the differential mode output.

In both of the feed arrangements, the ratio of wanted to unwanted signal is more than 30 dB

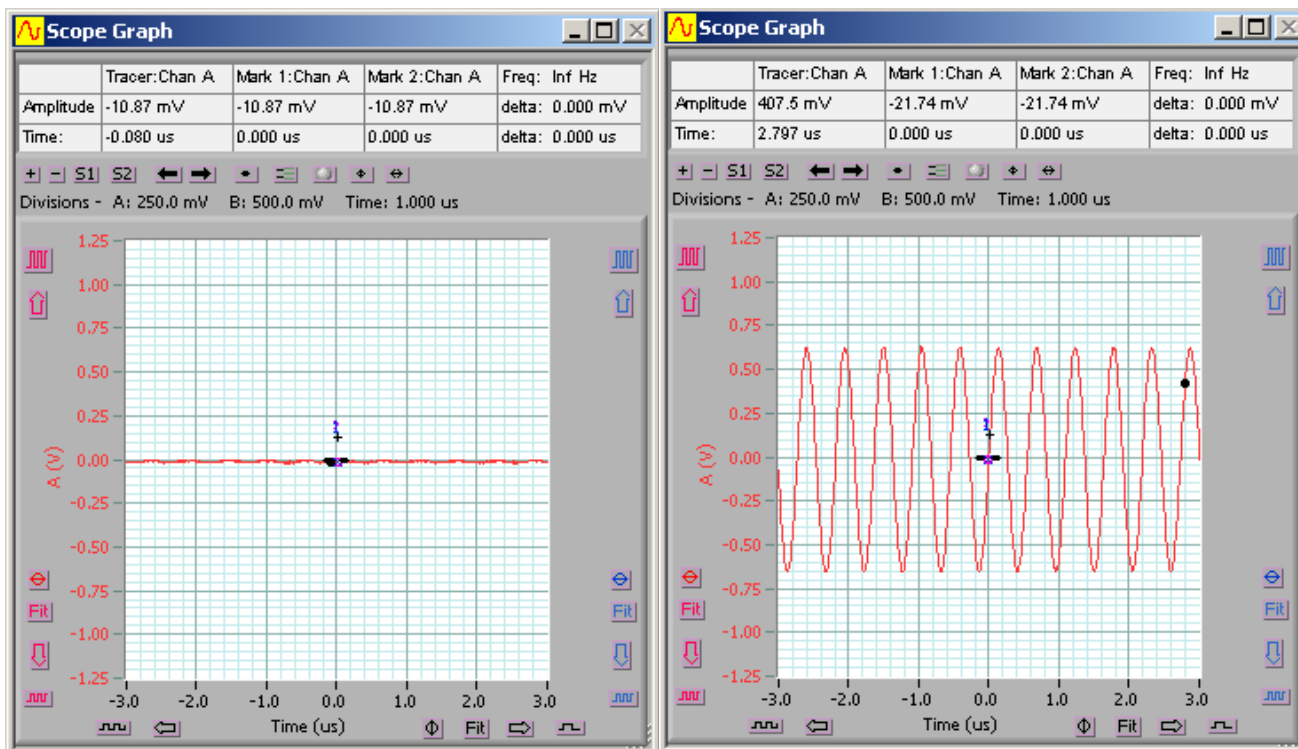
Feed T1 Sec, CM Output

Feed T1 Sec, DM Output

In the both the scope traces above, the secondary of T1 is fed with signal. The left hand trace shows the signal appearing at the common mode output, while the right hand trace shows the signal appearing at the differential mode output.

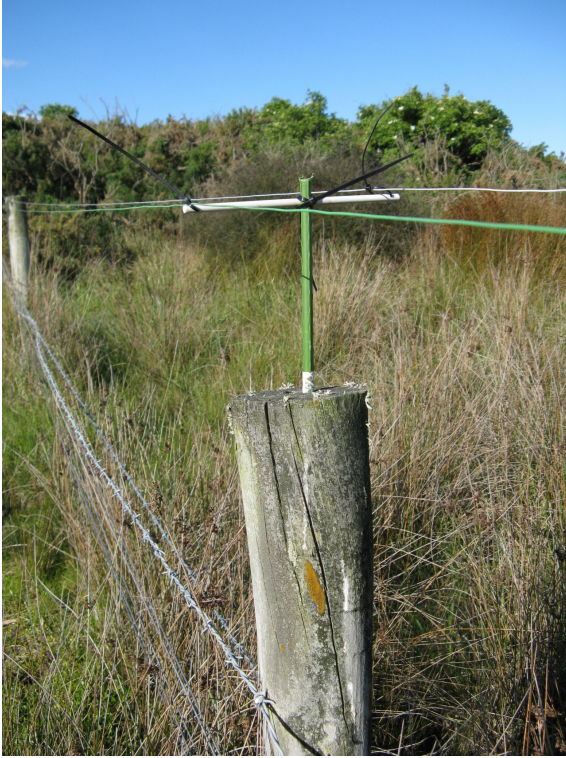
In order to avoid problems with excess attenuation, I decided to employ an open 2-wire line, rather than a twisted pair such as WD1-A. I was lucky to have an existing fence available for the entire run of the 2-wire Beverage, and supporting the wires above the fence was quite a simple matter. I simply drilled a 9 mm hole in the top of every 2nd fence post, and inserted a 300 mm section of cheap garden stake. These 9 mm diameter stakes are available in various lengths from gardening shops. I cut 200 mm lengths of 6 mm round fibreglass rod, and drilled a 2.5 mm hole 10 mm from each end. I used a pair of cable ties to attach the rod to the top of the stake. I threaded a 2.5 mm cable tie through each of the holes, and enclosed it around the wire. Using this attachment method, the wire is constrained to sit on top of the rod, at a fairly tightly controlled spacing, while free to move through the cable tie in the longitudinal direction. This was for ease of tightening.

Photo 1 shows this original arrangement.

The height of the pair above ground is 1.2 m, and the spacing 180 mm. The wire diameter is 0.6 mm.

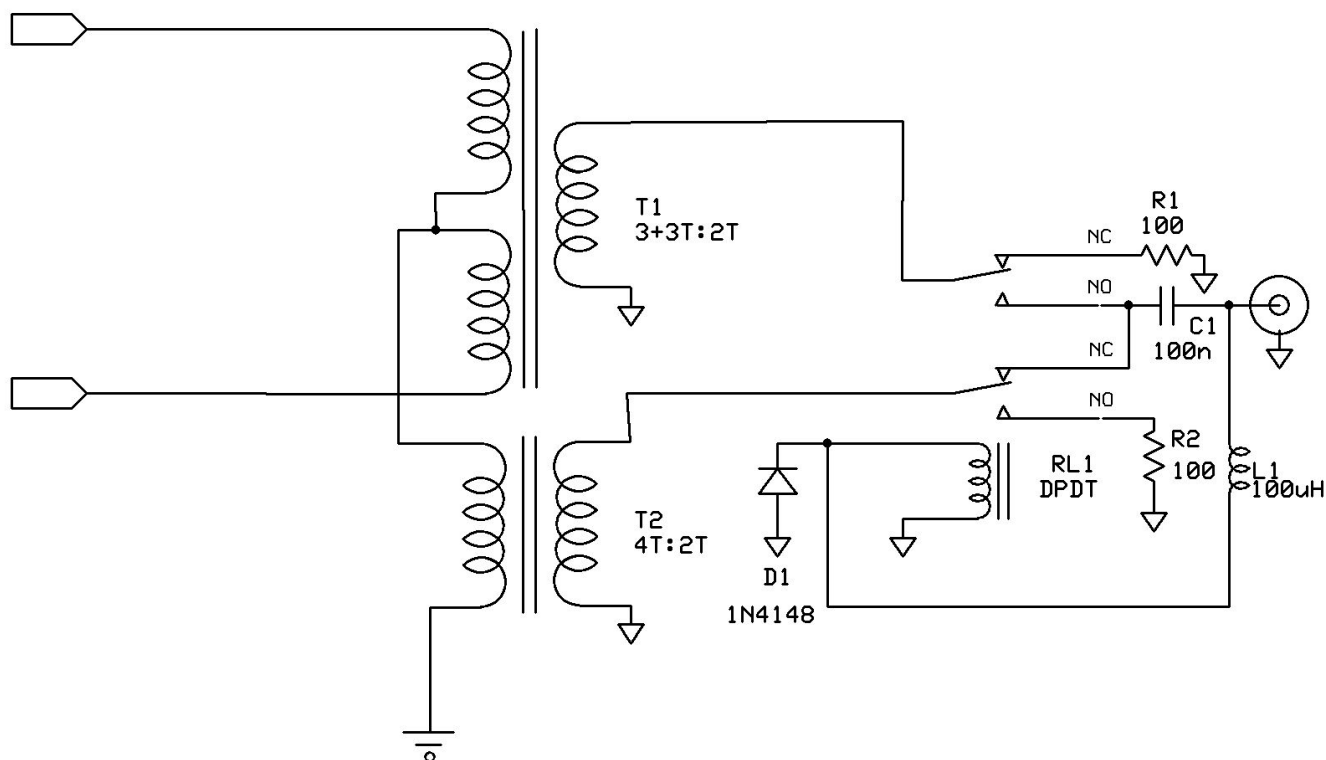
The schematic of the feed and switching box is shown above.

T1 and T2 are the differential mode and common mode coupling transformers respectively, and RL1 switches the output between them. RL1 is energised from the coax line, 0 V for forward, and +12 V for reverse. The inactive winding is switched to a matched load in each case. With lossless transformers, the loads would be 82 Ω , but the high permeability binocular cores used, do have a significant parallel loss resistance (about 500 Ω). R1 and R2 have therefore been increased in value so that the total parallel load is about 82 Ω .

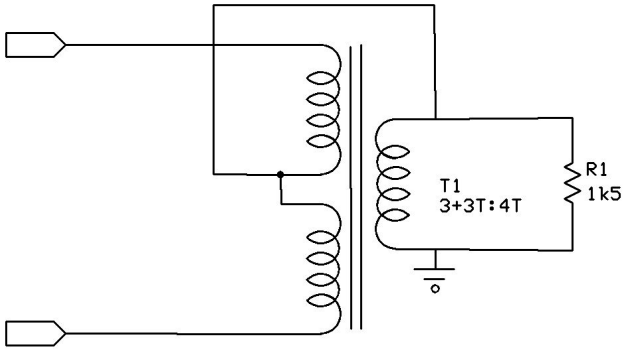
The schematic for the reflection transformer is shown below. T1 has an impedance transformation ratio of 2.25:1. It collects the common mode currents arriving from the Beverage reverse direction, matches the common mode line impedance to the differential mode line impedance, and re-launches the signal in differential mode. The purpose of R1, is to add a small shunt load across the transformed differential mode impedance. The parallel combination so obtained, added to the measured ground connection resistance, equals the common mode impedance of the line, and results in minimum reflection in this mode. If this step were not taken, the error described in 3.1.3 would result.

The addition of R1 does result in a small loss, probably about 1 dB. Alternative ways to compensate for the ground connection resistance, would be either to modify the turns ratio of T1 slightly, or to add a second transformer. T2, between the centre tap of T1 and the coupling winding. In practice, changing the turns ratio of T1 would not be easy, as 3.5 T would be needed for the coupling winding. I am suspicious of half turns used on binocular cores, as the balance may be affected.

Later note – R1 was omitted after increasing the height of the antenna, as the match provided by the reflection transformer alone, was then close enough.

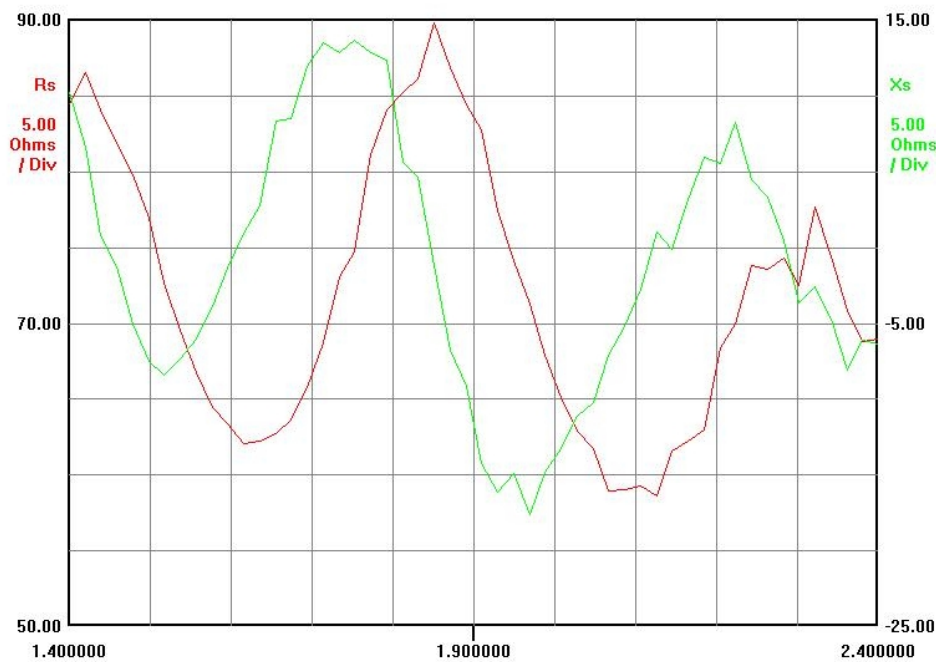
For this measurement, the VNA was used in Reflection Mode, with a 9:1 coupling transformer between it and the 2-wire line. A 1 kΩ pot was connected across the far end of the line, and adjusted for the best impedance flatness. Photo 2 below shows a mismatched case. There are larger variations in both the real and imaginary parts of the impedance, as the VNA frequency is swept.

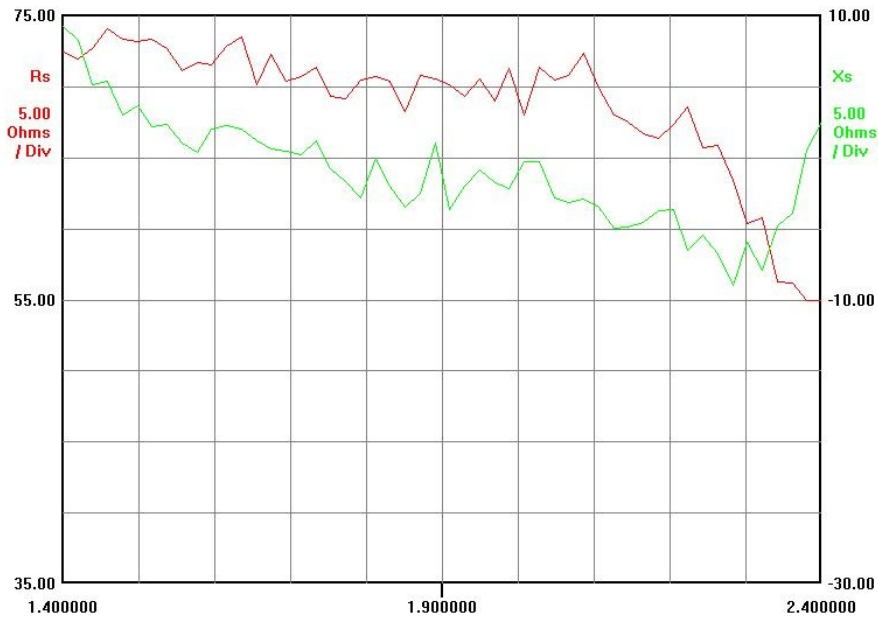
Photo 3 below shows the matched case.

The matched case is when the far end termination was 760 Ω , which is therefore the differential mode impedance. This value is very close to the theoretically predicted value for the 2-wire line. Note that the actual value of the impedance measured by the VNA at 1.8 MHz is about 72 Ω . Referred to the high Z side of the 9:1 transformer, this is 648 Ω . The coupling transformer itself has an equivalent parallel loss resistance of 4500 Ω , however. Taking this into account, the corrected value for the impedance is 757 Ω .

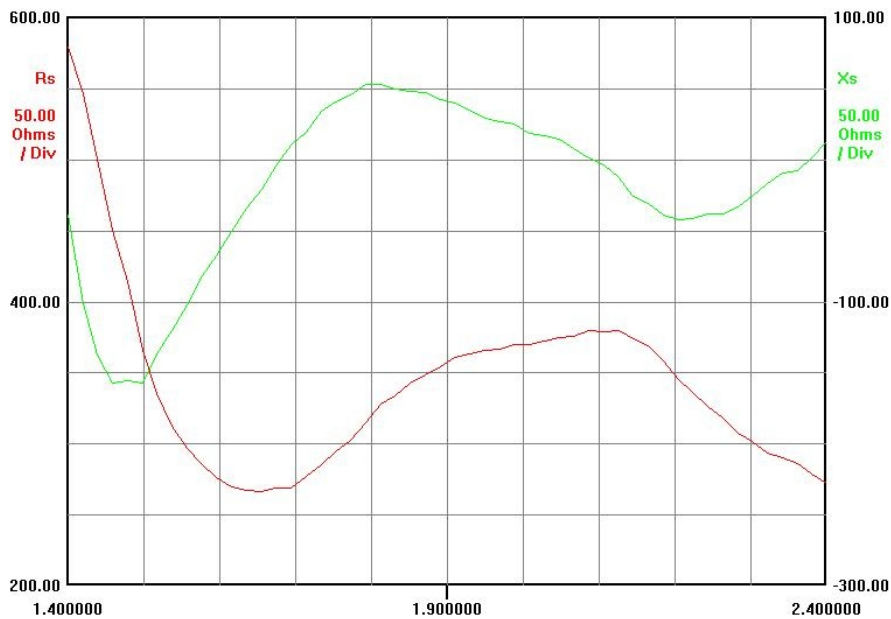
Photo 4.

In this test, the pot value had very little influence on the impedance seen at the feed end, suggesting that there is a significant transmission loss associated with common mode transmission. The feed impedance was close to 360 Ω regardless of the pot setting. Photo 4, below, shows the impedance plot.

Although the real part of the impedance is close to the 360Ω theoretical value at 1.8 MHz, there is considerable variation across the band. This plot was taken when the wire were close to the fence, which may be influencing the results. The measurement was not repeated after raising the antenna to its new height.

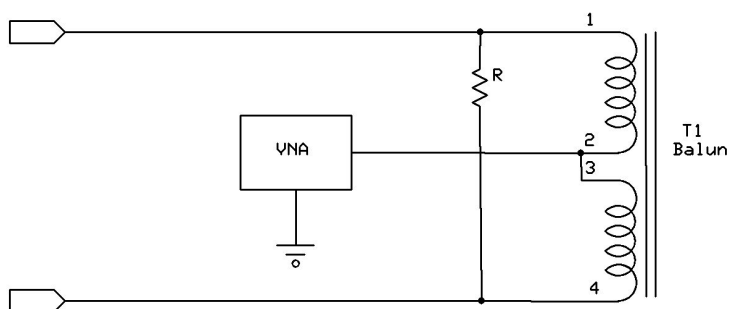
5.3 Common Mode Match Provided by Reflection Transformer.

As for the common mode impedance measurement, the results of this test were inconclusive.

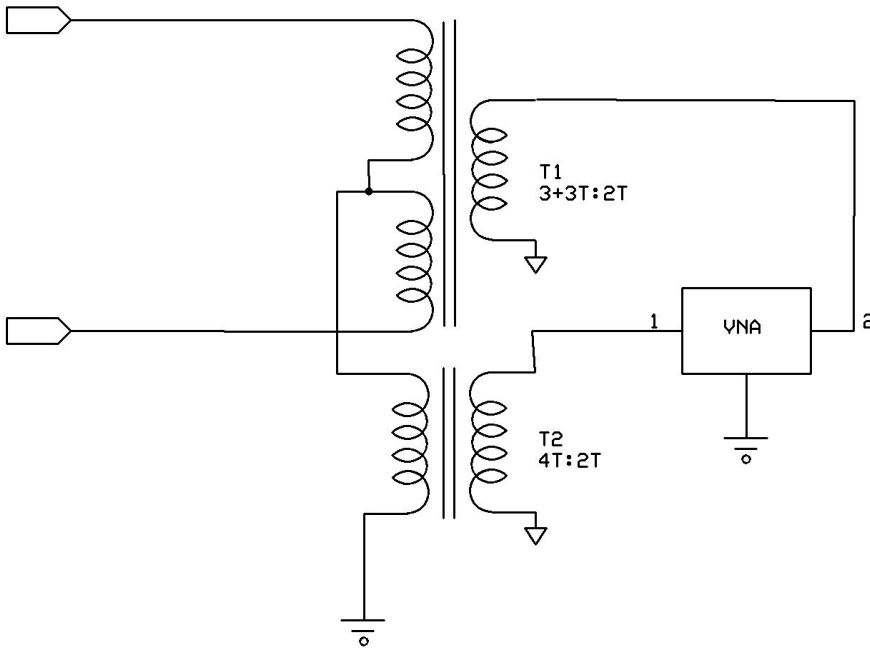
For this test, the VNA was used in Transmission Mode. Its output port was connected between the common mode port of a substitute feed transformer and ground. Its input port was connected to the differential port of the transformer, as shown in the schematic below.

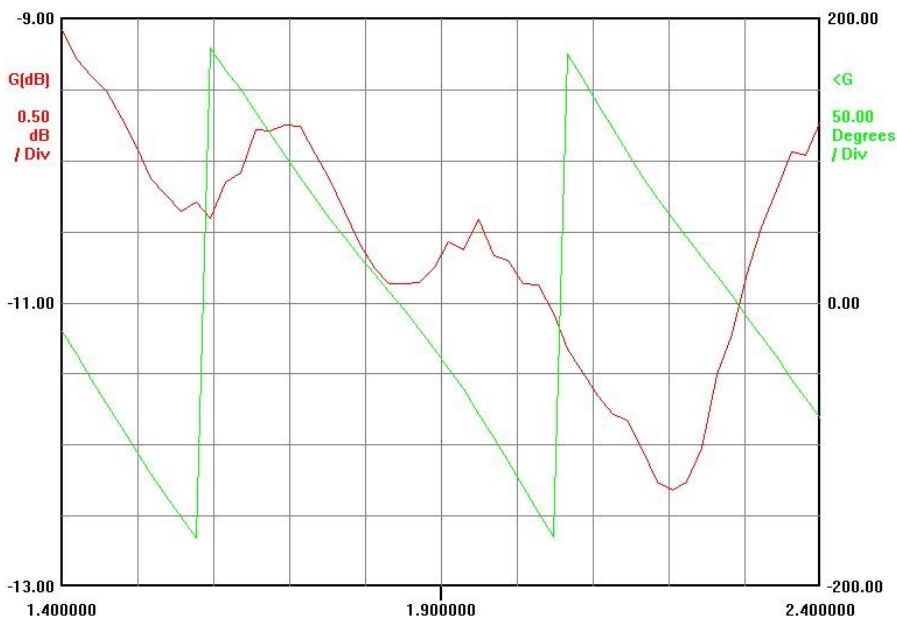
Photo 5.

Photo 5 shows the swept insertion loss, which is close to 10 dB. Either the forward or reverse path therefore has significant loss (or both) From the common mode impedance measurement, it is likely that the forward path has the dominant loss.
